## VEHICLE INSPECTION REPORT

| Inspector | Provided by | Date |
|---|---|---|
| H. Filali | Carspector GmbH | 08.09.2026 |

| Parameter | Value | Parameter | Value |
|---|---|---|---|
| Manufacturer | Audi | VIN | WAUZZZF85RN007697 |
| Model | A8 | Type | Sedan |

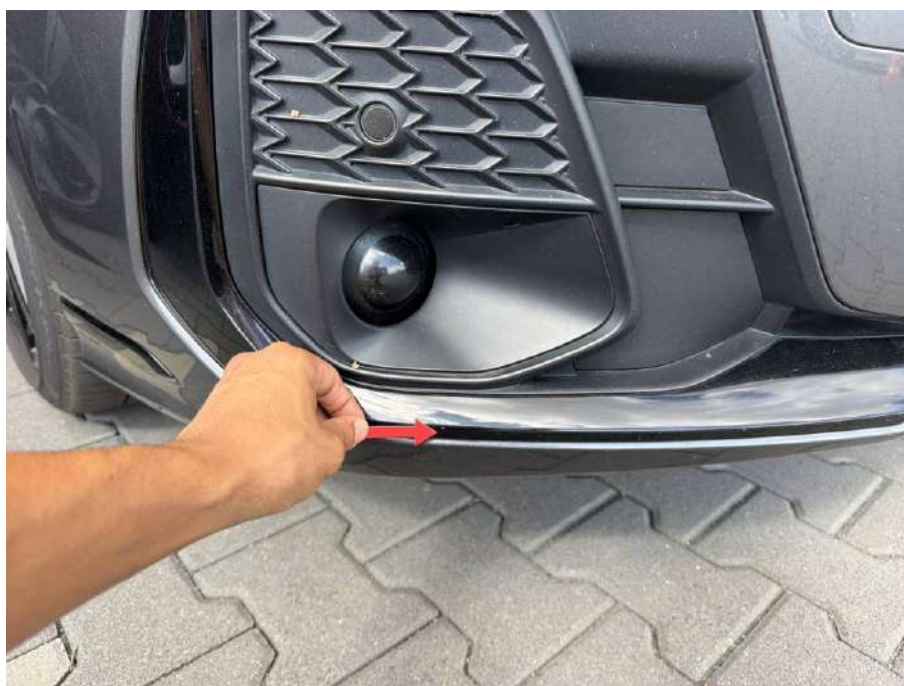
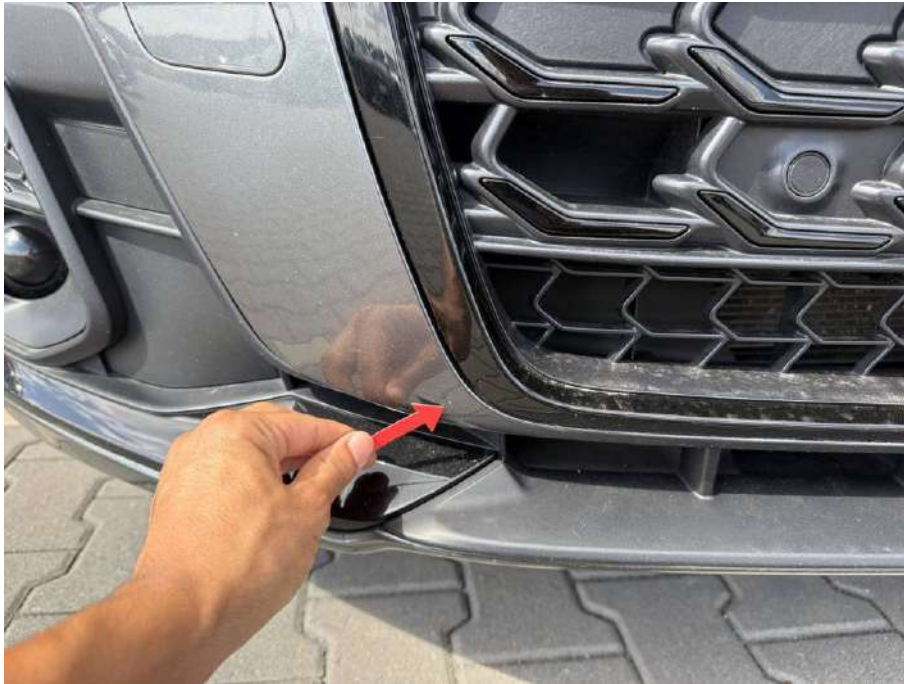
| Component | Condition | Damages / Findings |
|---|---|---|
| Front bumper | Damaged | 🚩 Stone chip |

Photo 28 : Front Bumper - Stone Chip

Photo 29 : Front Bumper - Stone Chip

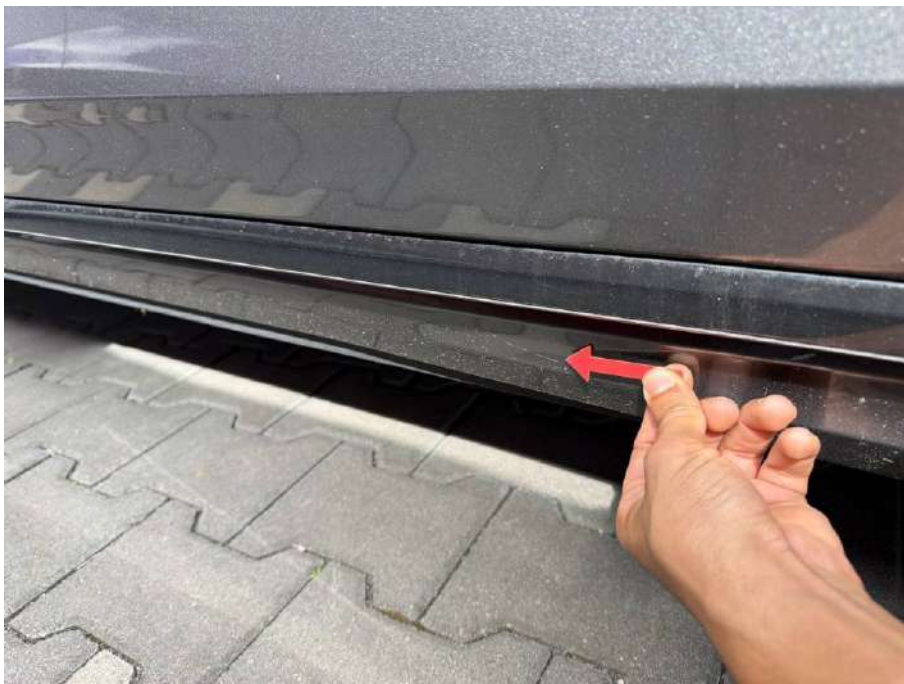
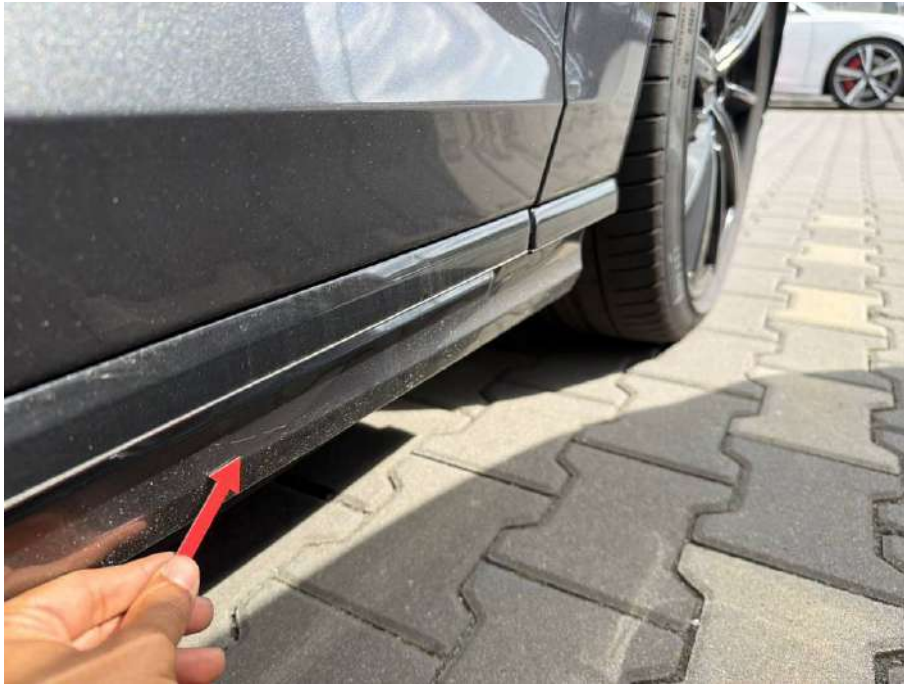
| Component | Condition | Damages / Findings |
|---|---|---|
| Sill right | Damaged | 🚩 Scratch |

Photo 30 : Right Sill - Scratch

Photo 31 : Right Sill - Scratch

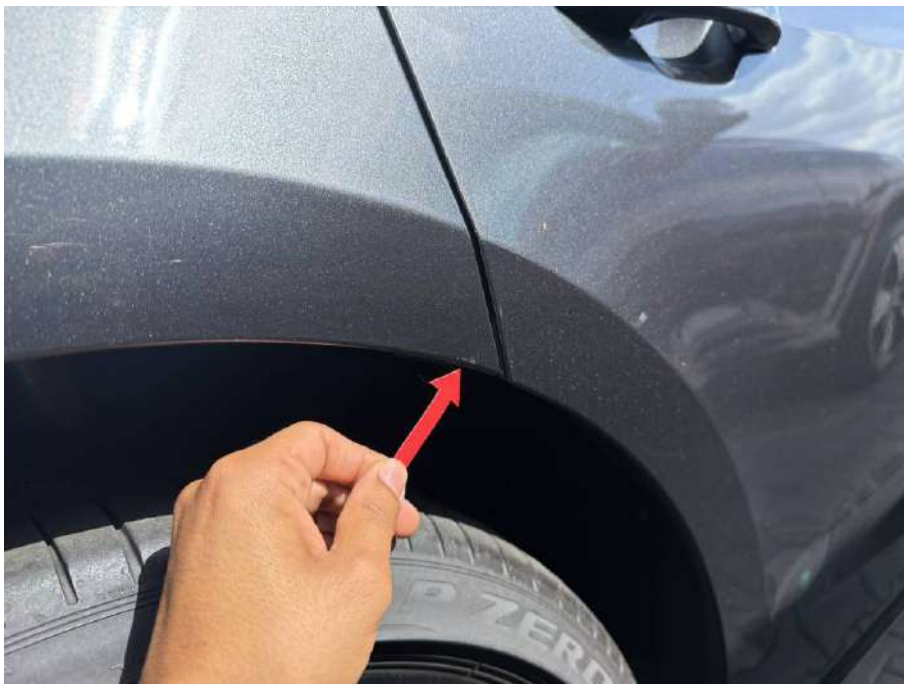
| Component | Paint layer thickness (µm) | Repainted? | Damages / Findings |
|---|---|---|---|
| Sidewall RR | 105 µm | No | 🚩 Scratch |

Photo 32 : Rear Right Quarter Panel - Scratch

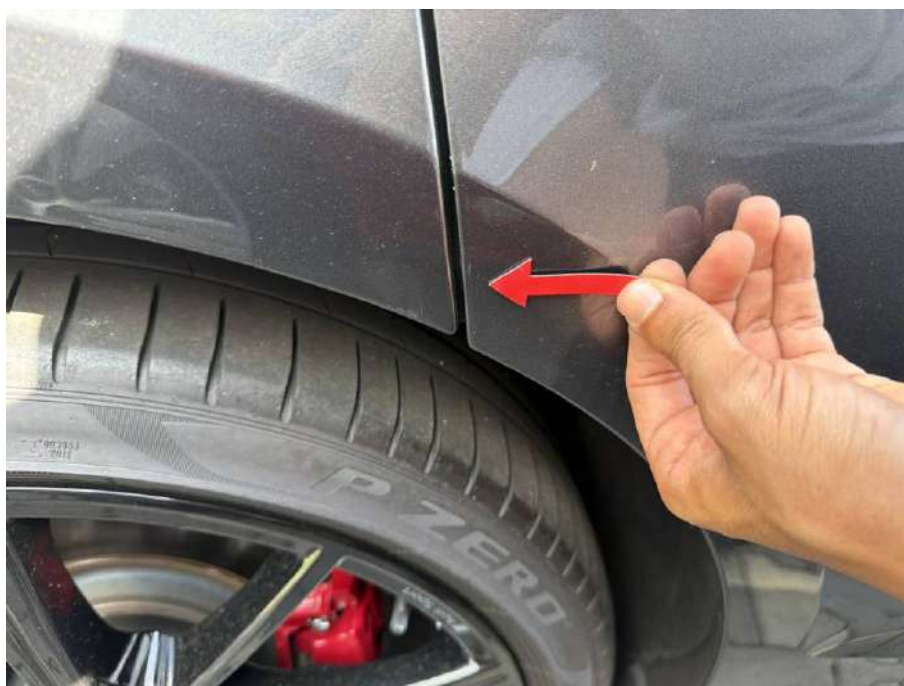
| Component | Paint layer thickness (µm) | Repainted? | Damages / Findings |
|---|---|---|---|
| Door RR | 100 µm | No | 🚩 Scratch |

Photo 33 : Rear Right Door - Scratch

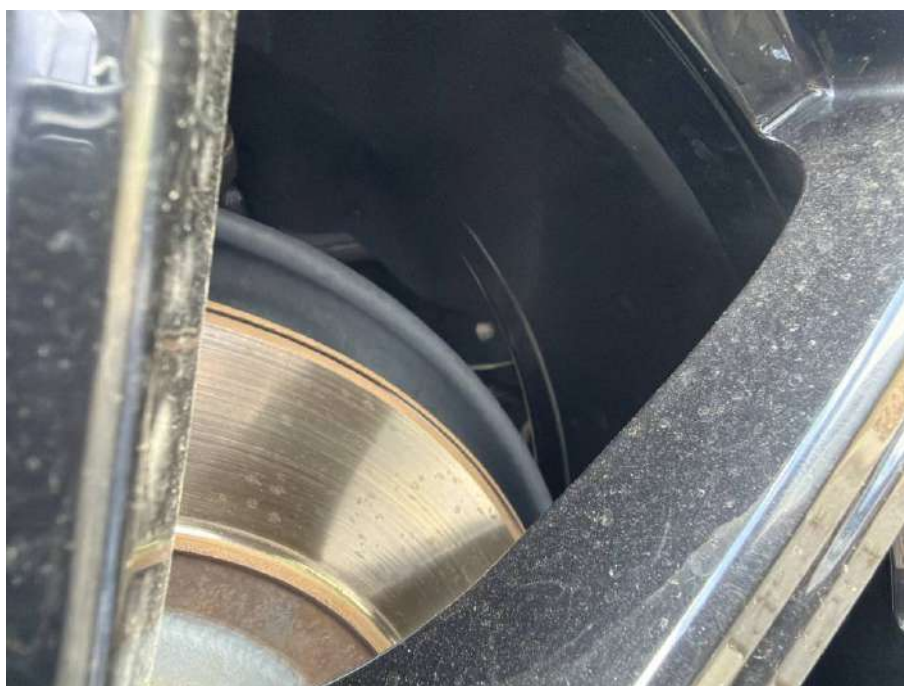
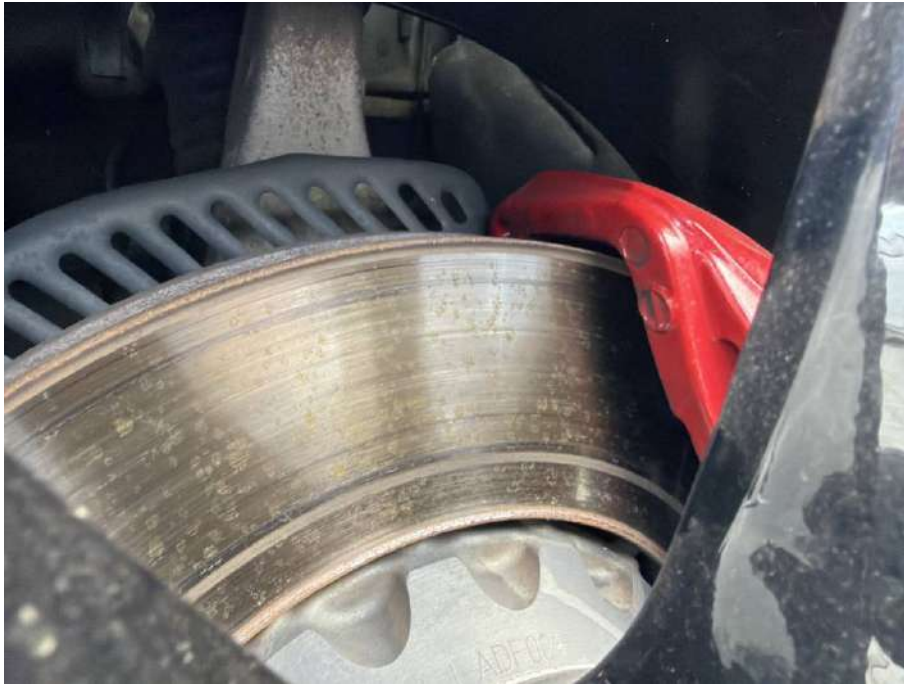
| Component | Condition | Damages / Findings |
|---|---|---|
| Brake discs | Damaged | ⚠ Other: Close to wear limit |

Photo 34 : Brake Discs - Close to wear limit

Photo 35 : Brake Discs - Close to wear limit

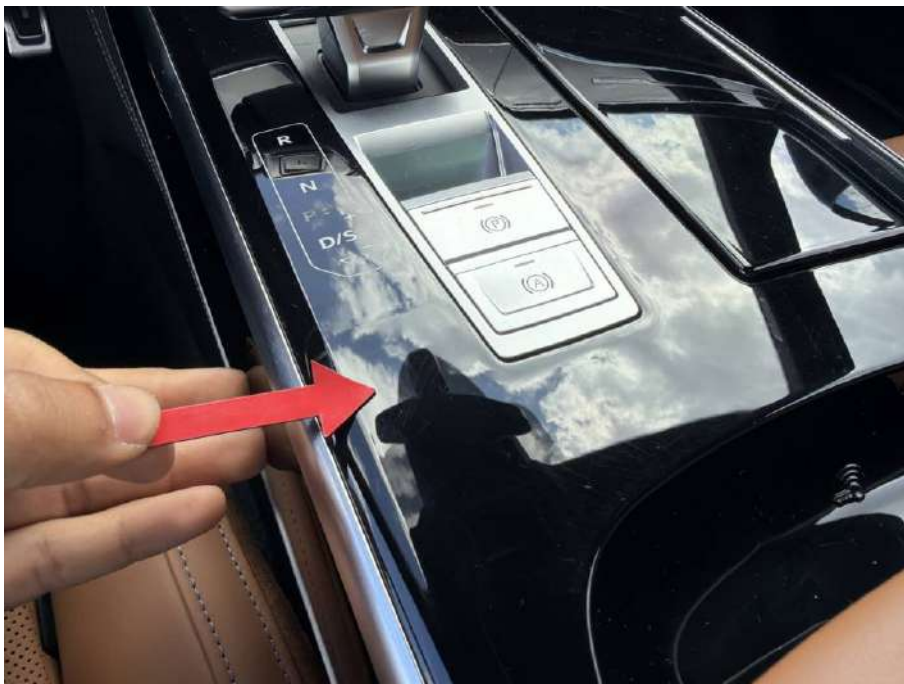
| Component | Condition | Damages / Findings |
|---|---|---|
| Dashboard | Damaged / faulty | ⚠ Scratch |

Photo 36 : Dashboard - Scratch

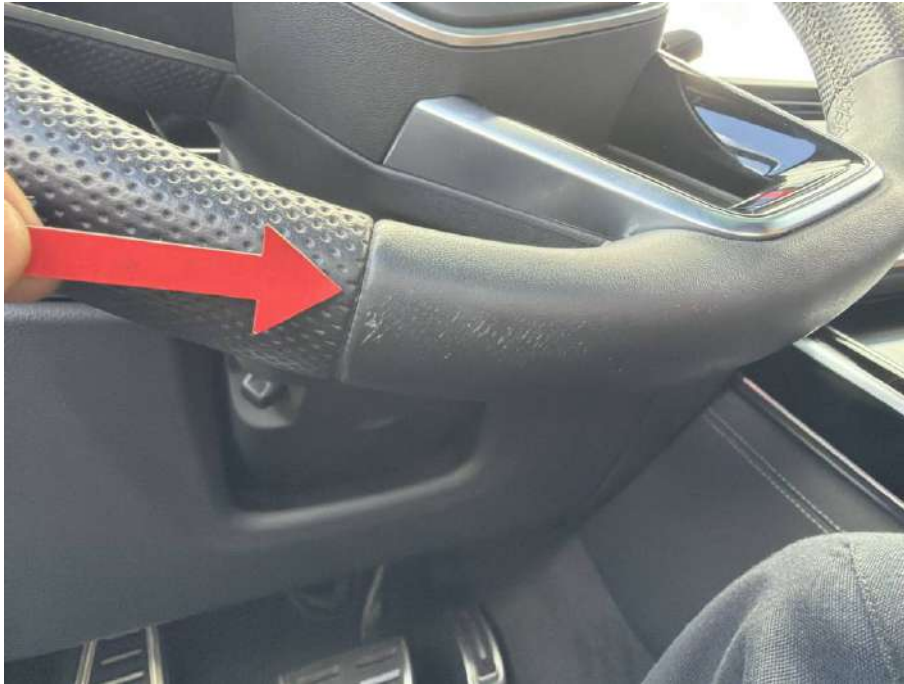
| Component | Condition | Damages / Findings |
|---|---|---|
| Steering wheel | Damaged / faulty | ⚠ Other: Signs of wear |

Photo 37 : Steering Wheel - Abrasion / Wear

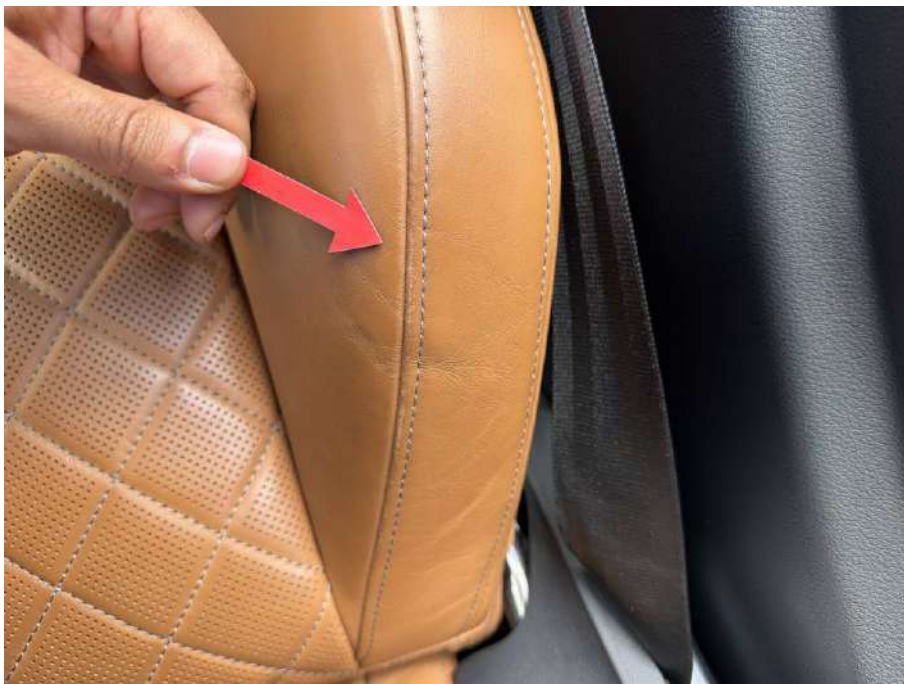
| Component | Condition | Damages / Findings |
|---|---|---|
| Seats | Damaged / faulty | ⚠ Signs of wear |

Photo 38 : Seats - Signs of Wear
