## VEHICLE INSPECTION REPORT

| Inspector | Provided by | Date |
|---|---|---|
| H. Filali | Carspector GmbH | 08.09.2026 |

| Parameter | Value | Parameter | Value |
|---|---|---|---|
| Manufacturer | Audi | VIN | WAUZZZF85RN007697 |
| Model | A8 | Type | Sedan |

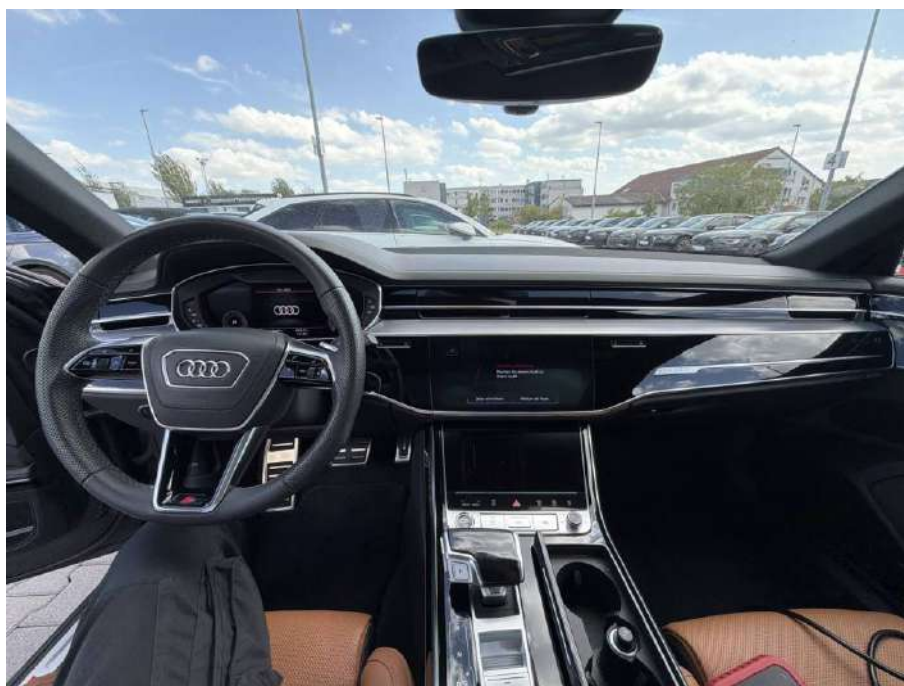
Photo 11 : Cockpit / Dashboard

| Component | Condition | Damages / Findings |
|---|---|---|
| Dashboard | Damaged / faulty | ⚠ Scratch |

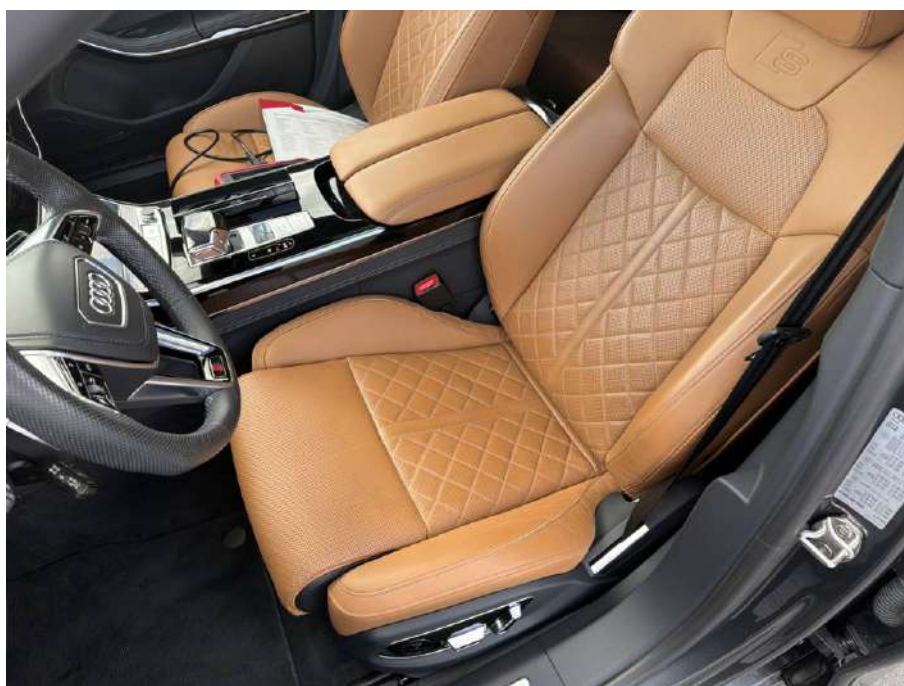
Photo 12 : Driver Seat

| Component | Condition | Damages / Findings |
|---|---|---|
| Seats | Damaged / faulty | ⚠ Signs of wear |

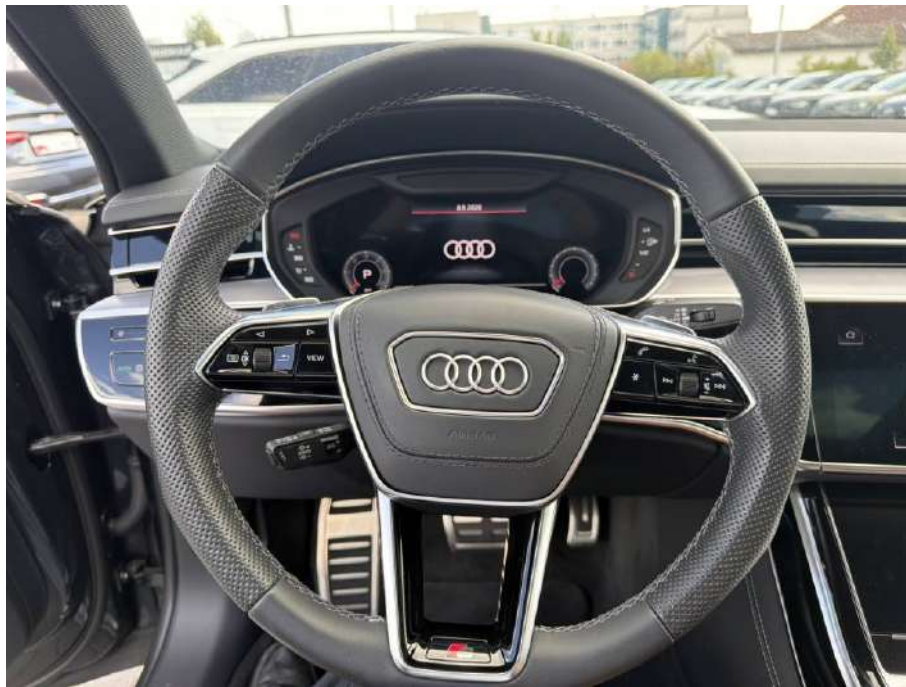
Photo 17 : Steering Wheel

| Component | Condition | Damages / Findings |
|---|---|---|
| Steering wheel | Damaged / faulty | ⚠ Other: Signs of wear |
